***Operation and Maintenance Plan for INTEC Operable  
Unit 3-13, Group 1, Tank Farm Interim Action***

April 2005

DOE/ID-10771  
Revision 3  
Project Nos. 020978 and 023614

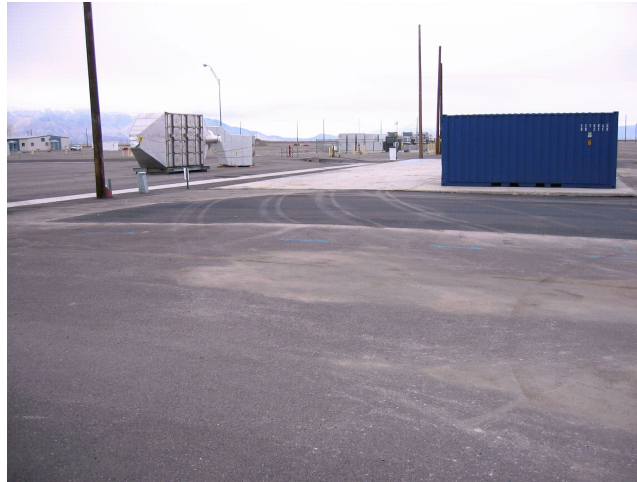
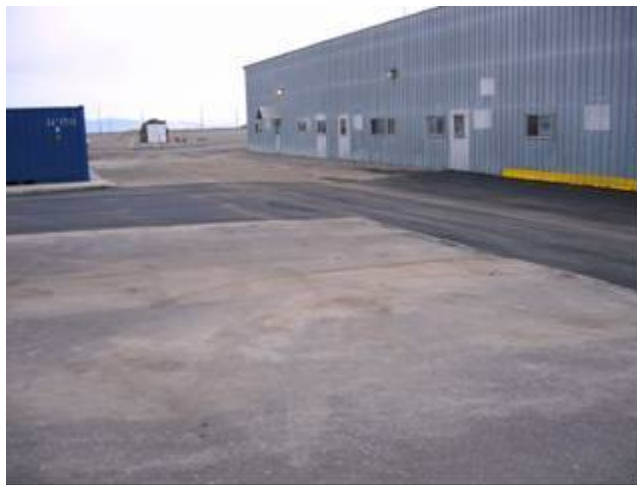
Asphalt Classification 0 – New asphalt free of cracks, defects, subsidence.

- Asphalt Classification 0 – New asphalt free of cracks, defects, subsidence.
- Asphalt Classification 1 – Existing asphalt in good condition, maintenance not required.
- Asphalt Classification 2 – May contain minor cracks, slight uneven surface, and/or may contain areas that have previously been repaired. Requires regular inspections.
- Asphalt Classification 3 – Contains cracks, holes, subsidence that require repair. Deep-patterned cracks that extend through the surface and reach the subgrade and base material.
- Asphalt Classification 4 – Asphalt containing major defect(s), requires replacement.

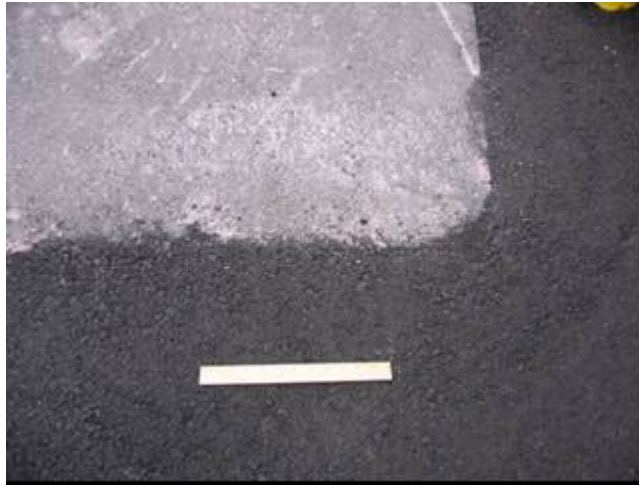
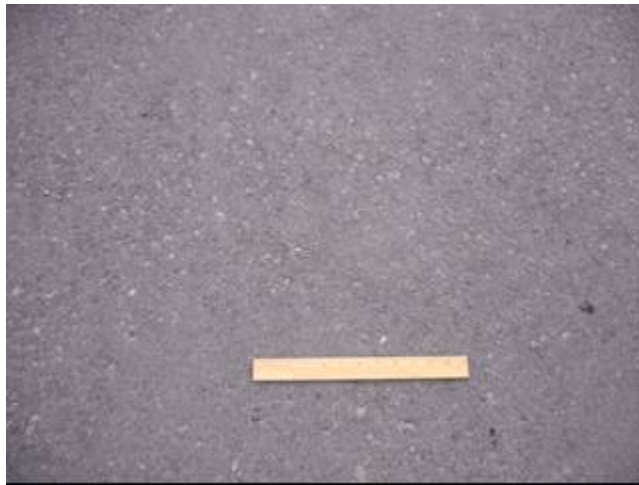
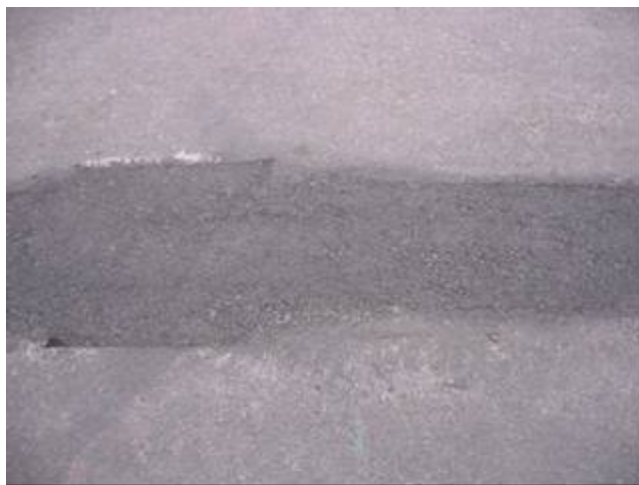
Asphalt Classification 1 – Existing asphalt free from cracks, hole, defects, subsidence.

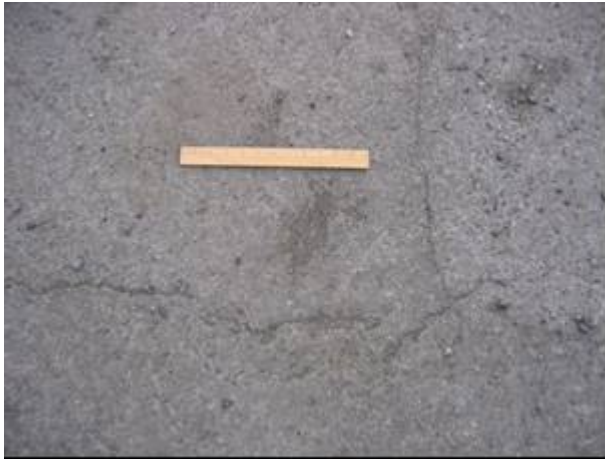
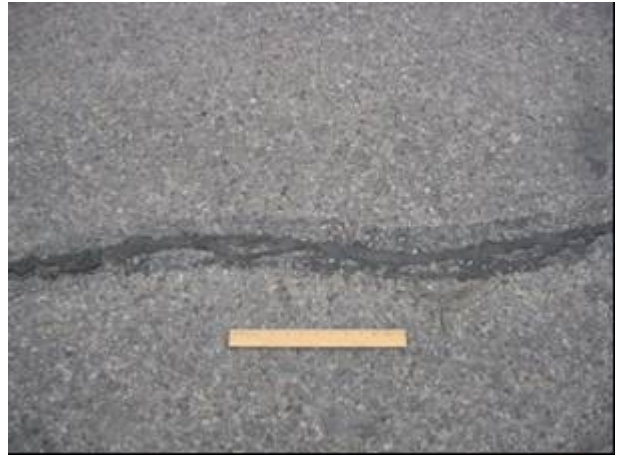
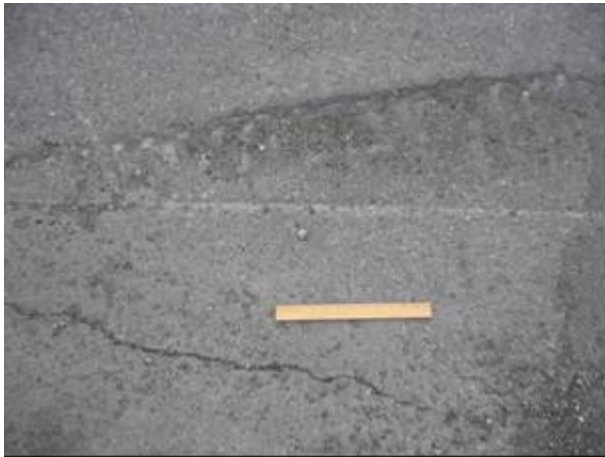
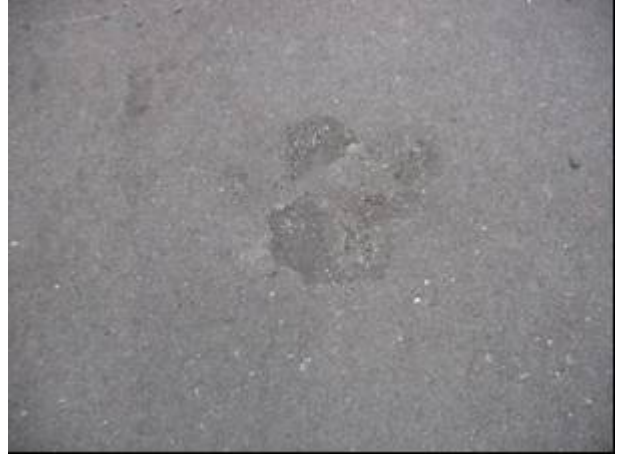
Asphalt Classification 2 – May contain minor cracks, slight uneven surface, and/or may contain areas that have previously been repaired. Requires regular inspections.

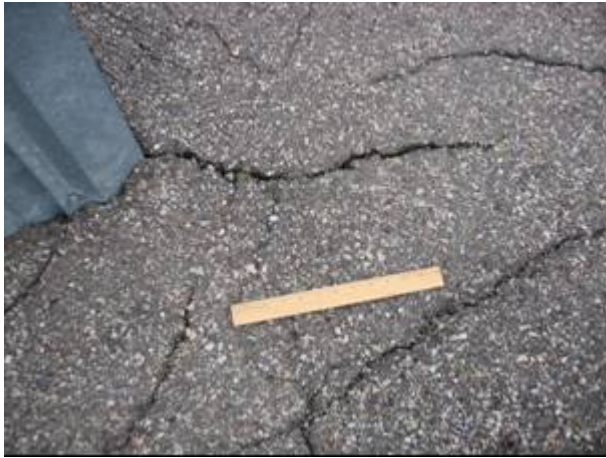
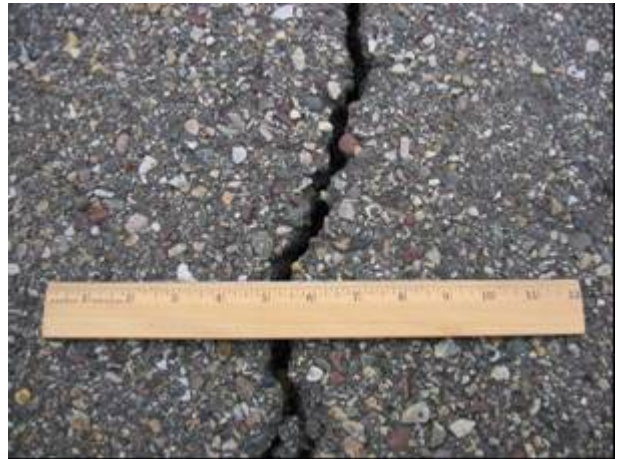
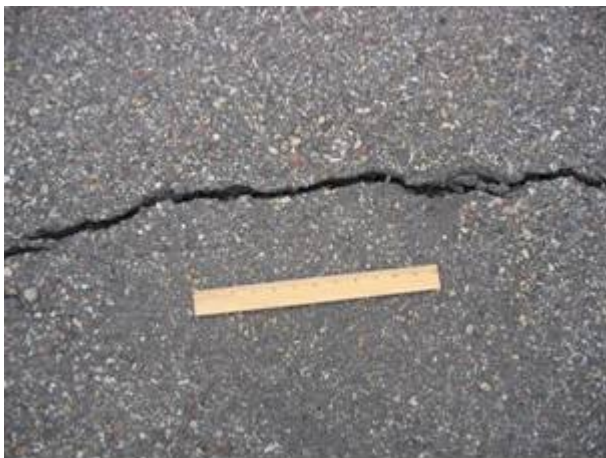
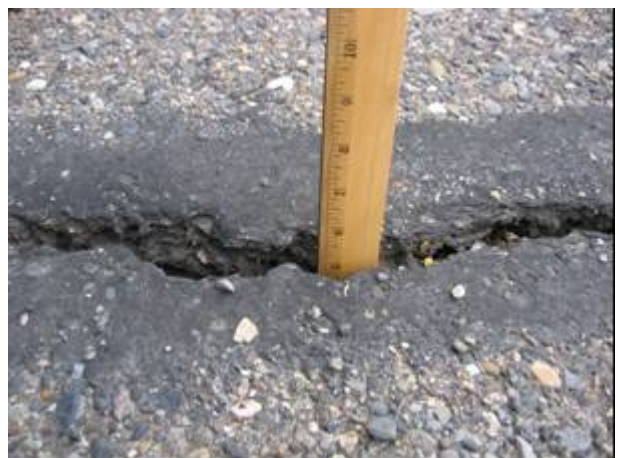
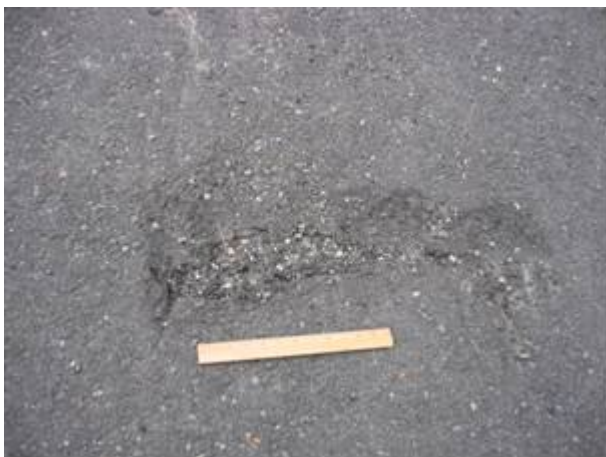
Asphalt Classification 3 – Contains cracks, holes, subsidence that require repair. Deep-patterned cracks that may extend through the surface and reach the subgrade and base material.

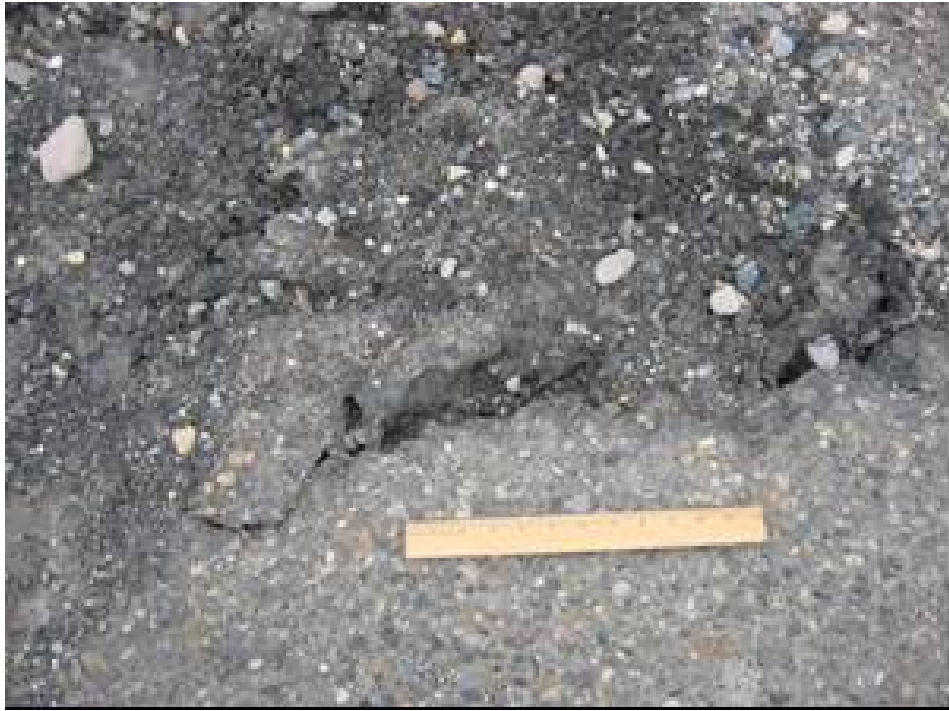
Asphalt Classification 4 - Asphalt containing major defect(s), requires replacement.

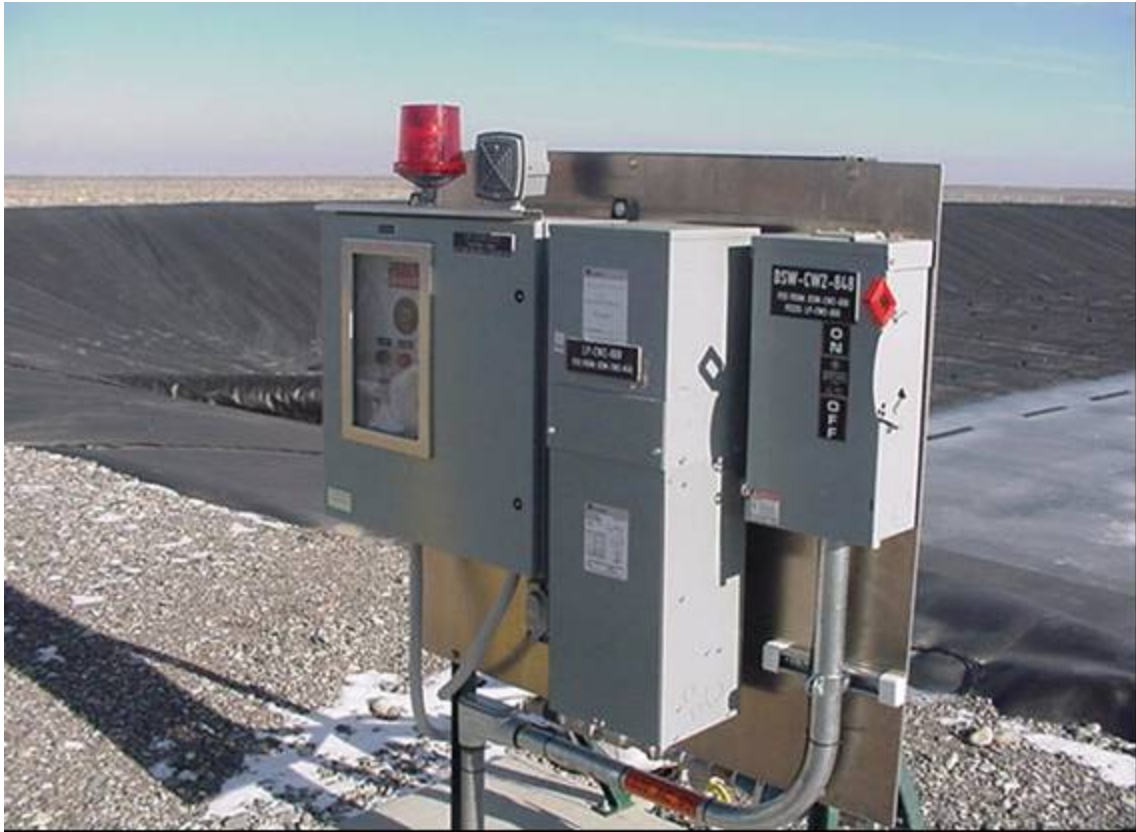
Figure D-1. Leak detection system sump pump control panel with main disconnect.

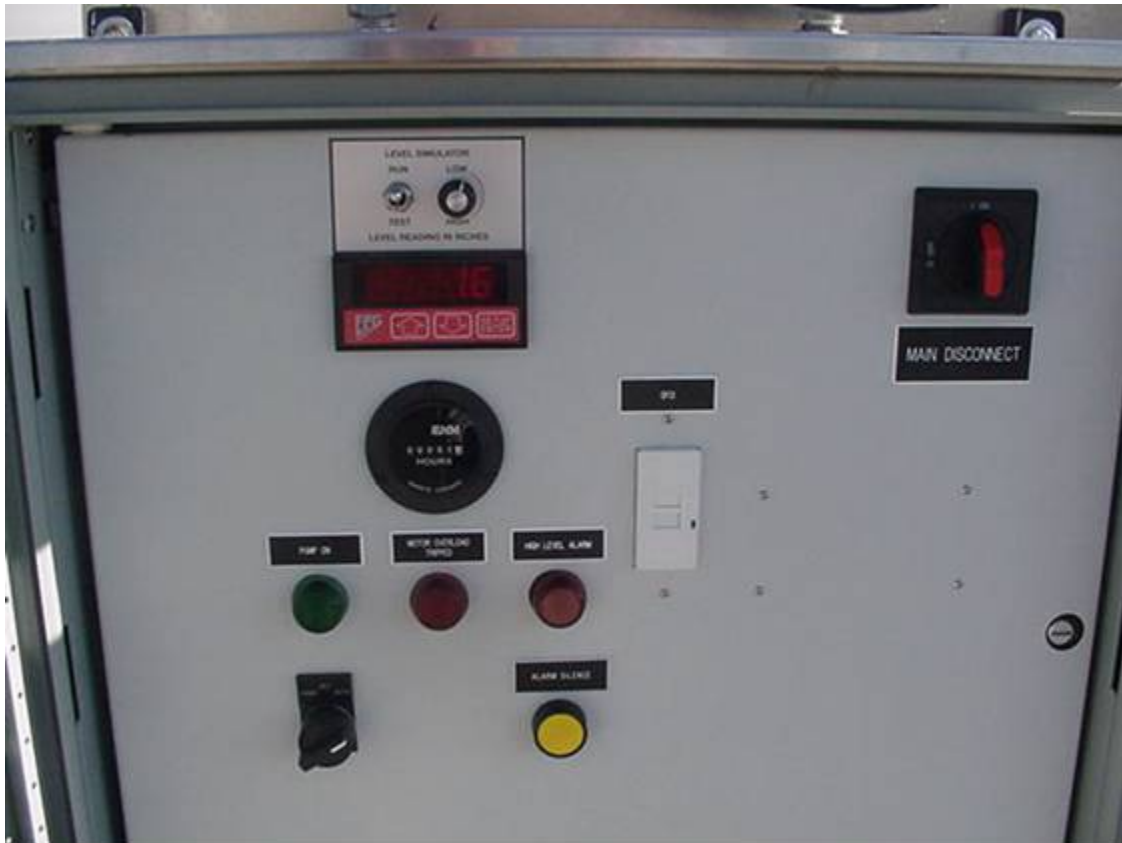
Figure D-3. Inside control panel of leak detection system.
